LLL: UCRL-52533
NASA: CR-159512

HIGH-PERFORMANCE FIBER/ EPOXY COMPOSITE PRESSURE VESSELS

T. T. Chiao, M. A. Hamstad, E. S. Jessop, and R. H. Toland

December 12, 1978

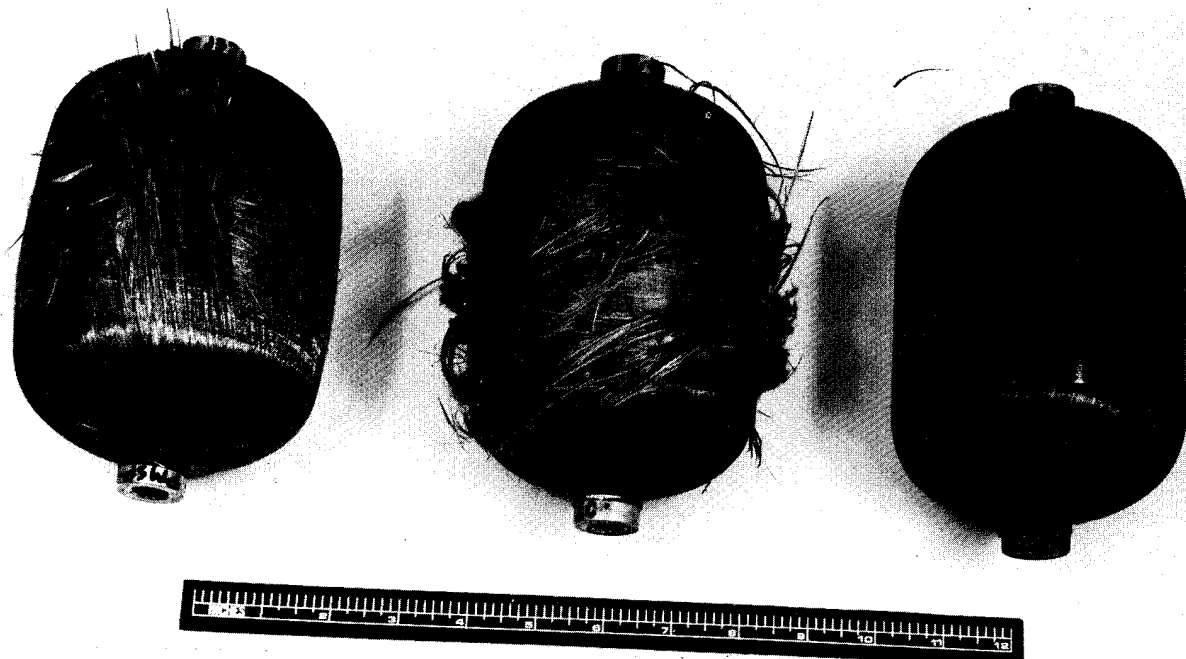
Fig. 32. Photograph of two typical hoop failed vessels (a, b) and a typical unfailed pressure vessel (c).

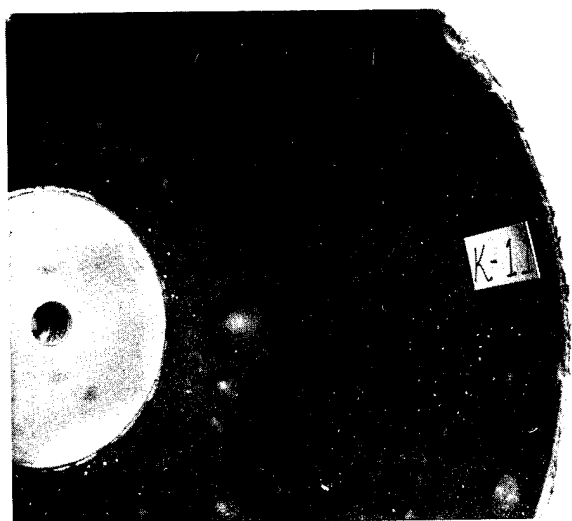
Fig. 41. Photograph of the interior of the K-11, 20.3-cm-diameter pressure vessel showing the pitted Parylene C liner.

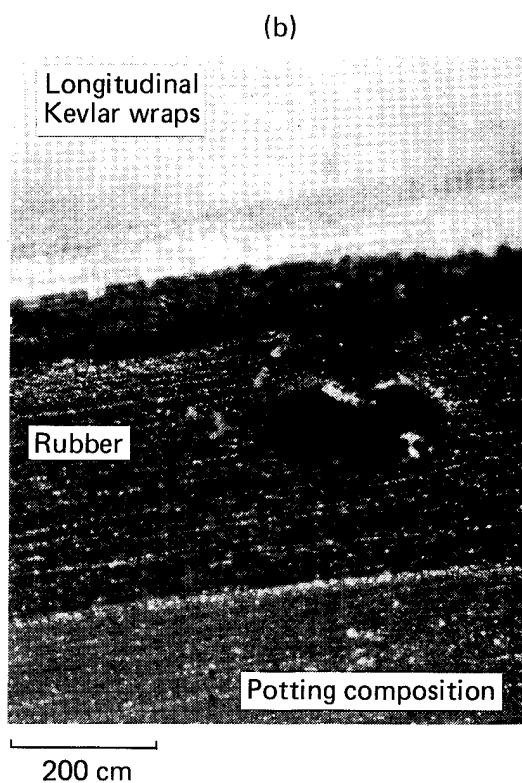
Fig. 43. Photomicrographs of four wall sections illustrating some of the problems with the liners: (a, b) 20.3-cm³-diameter vessels with voids, (c, d) 10.2-cm-diameter vessels with rubber migration.
